Built on Success

Utilising Advanced NDT Inspection Technologies

Real-World Case Studies in Asia

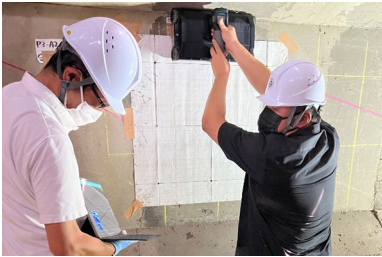
Advanced Ground Penetrating Radar (GPR): Accurately maps rebars and PT cables in bridge girders with Proceq GP8100 GPR. Initial superline scans in X & Y, followed by detailed area scans for comprehensive analysis.

Depth slicing and 3D imaging with AR overlays ensure precise marking of locations.

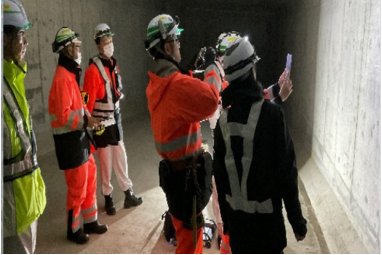
Video Scope Inspections: Non-invasive borescopes assess cable and grout conditions, confirming grouting defects. Standard practice in Japan and beyond, enhancing safety and longevity of post-tensioning systems.

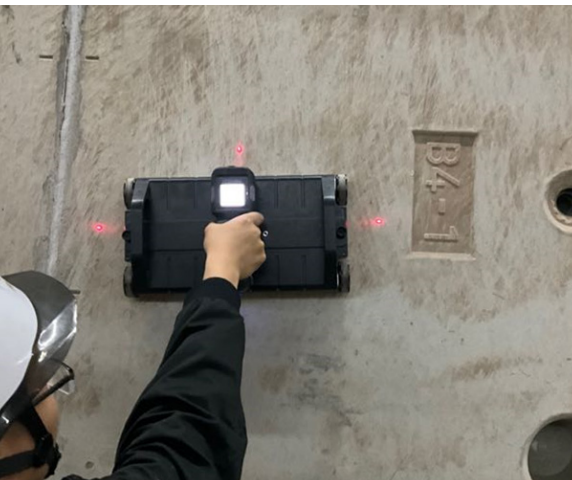
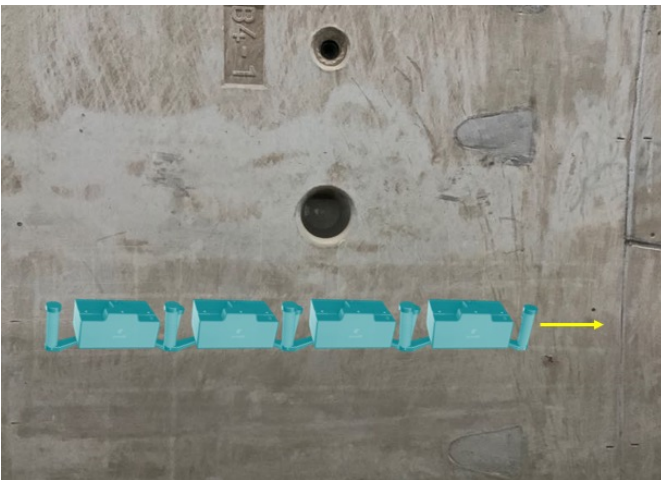
The **Proceq GP8100** Ground Penetrating Radar (GPR) is deployed to perform high-resolution imaging of tunnel linings, providing detailed insights into potential areas of concern. Increased signal intensity in certain areas may indicate potential water saturation. These findings should be compared with radar scans from non-saturated areas to confirm the extent of the seepage.

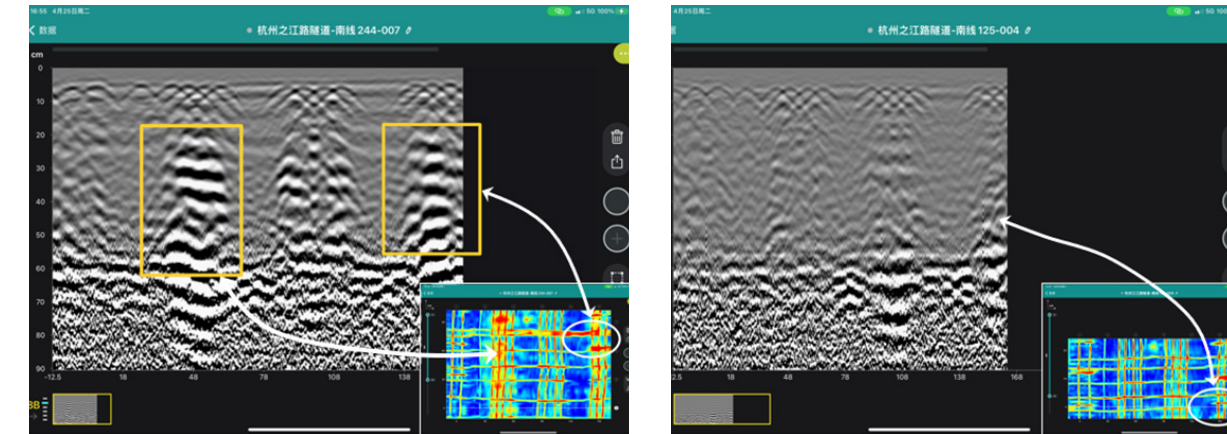
This figure contrasts radar images from a suspected water-saturated area with those from a non-saturated area. The suspected area shows noticeable increased signal intensity between reinforcing bars and the base slab, indicating water seepage, while the non-saturated area shows no such signals.

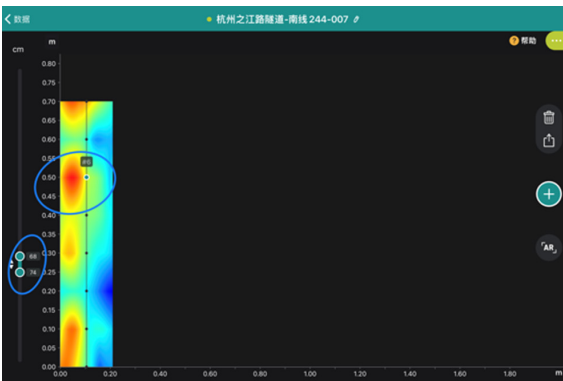
PD8050 scans reveal a significant void reflection in the suspected area, consistent with the GPR findings.

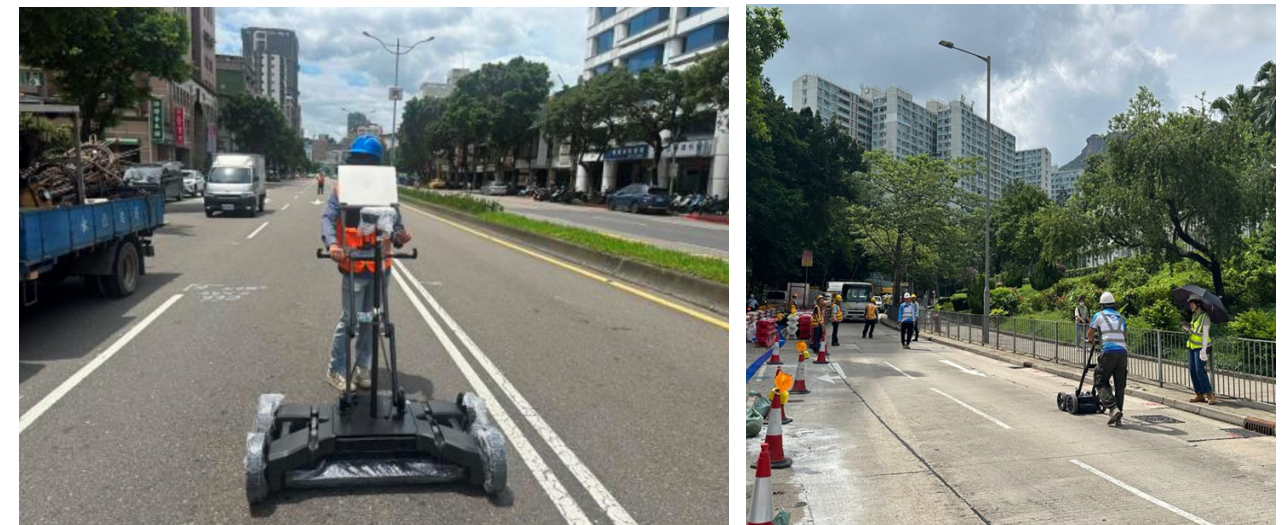
Advanced Ground Penetrating Radar (GPR) Proceq GS8000 and GS9000 provide:

- Versatile frequency ranges for various scanning depths, with the GS8000 suitable for medium-depth imaging at 40–3440 MHz, and the GS9000 offering deeper scans at 30–750 MHz and higher-resolution shallow scans at 500–3000 MHz.
- GPR systems paired with GNSS can operate without traditional survey grids, making the process faster and more flexible. This allows teams to scan areas based on specific conditions, improving the accuracy of data collection.
- Real-time 2D and 3D data processing for immediate anomaly detection and enhanced understanding of subsurface structures, improving field efficiency and safety.

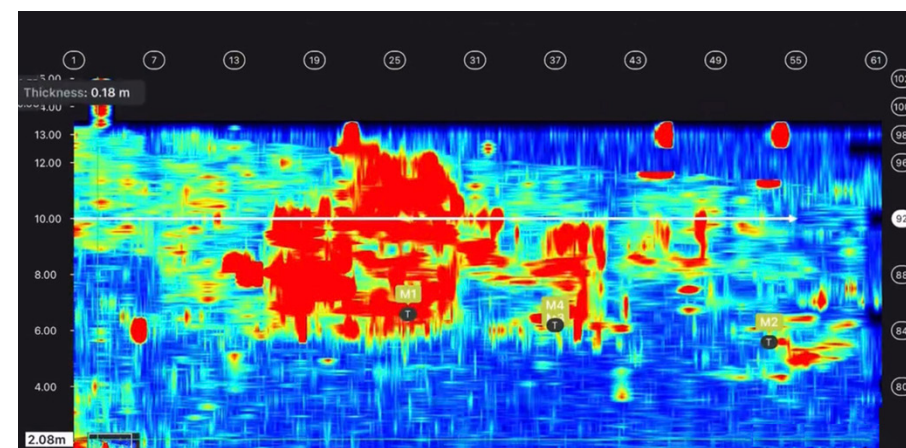
Scanned data showing possible cavity location

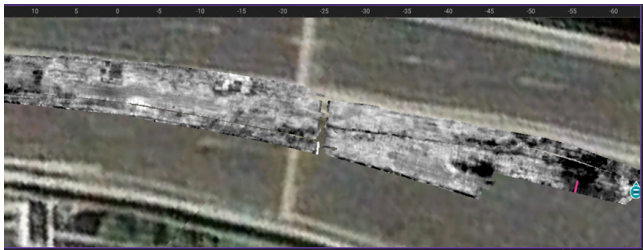
Interface defects between Asphalt-to-Concrete (A/C) layers (Delamination.)

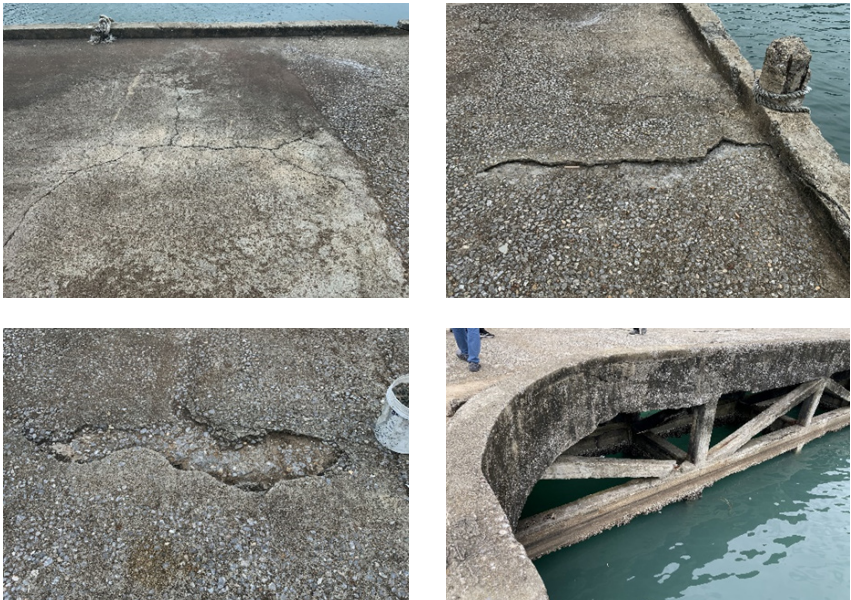
Visible surface cracks on the slabs and some columns.

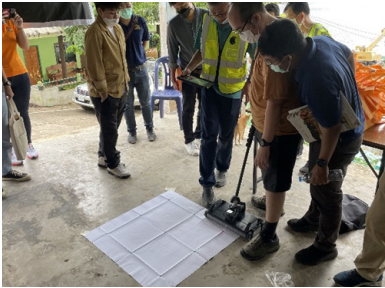
Advanced GPR Systems:

Internal Assessment: GP8100 GPR evaluates subsurface conditions, detects voids, corrosion, and deterioration in delaminated areas.

Detailed Analysis: GPR Insights software confirms air pockets, generates a 3D Condition Map overlaying surface delamination data for clear visualization of areas needing attention.

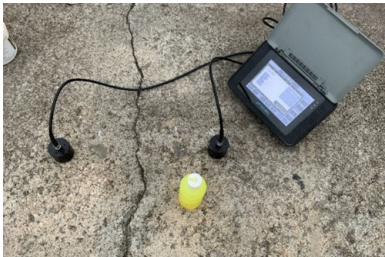
Ultrasonic Pulse Velocity (UPV):

Crack Depth Measurement: The Pundit-200 can be employed to measure the depth of surface cracks on the deck, providing critical insights into the extent of cracking and guiding effective repair strategies.
